**RE: Drinking Water Sampling – Kingston K-14 School District**  
10047 Diamond Road, Cadet, MO 63630  
**Project Number: 923334**

Drinking Water Assessment  
Kingston School District

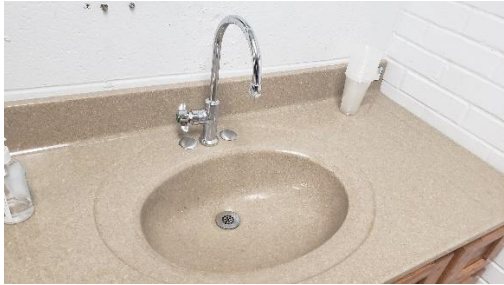
ID:	334-KSD-01	Location:	Classroom 321	
Photo:

Manufacturer:	Chicago Faucet Co.	
		Description:		
		Classroom Sink		
		Result:	3.4	ppb
		Date Sampled:	1/15/2024	By: NJ
Recommended Action:

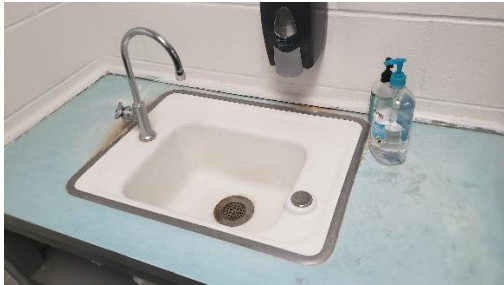
ID:	334-KSD-02	Location:	Classroom 320	
Photo:

Manufacturer:	Chicago Faucet Co.	
		Description:		
		Classroom Sink		
		Result:	4.7	ppb
		Date Sampled:	1/15/2024	By: NJ
Recommended Action:

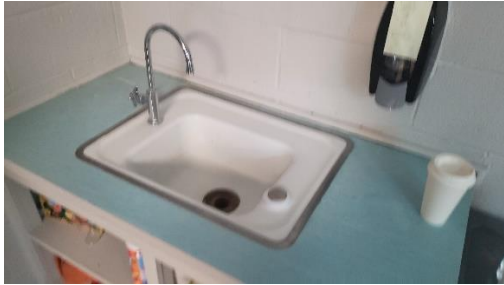
ID:	334-KSD-04	Location:	Classroom 322	
Photo:

Manufacturer:	Chicago Faucet Co.	
		Description:		
		Classroom Sink		
		Result:	3.7	ppb
		Date Sampled:	1/15/2024	By: NJ
Recommended Action:

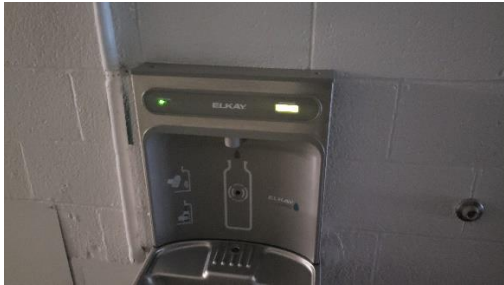
ID:	334-KSD-05	Location:	323 Hallway	
Photo:

Manufacturer:	Elkay	
		Description:		
		Drinking Fountain Bottle Filler		
		Result:	<1.0	ppb
		Date Sampled:	1/15/2024	By: NJ
Recommended Action:

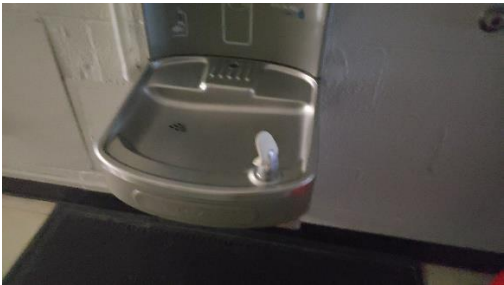
ID:	334-KSD-06	Location:	323 Hallway	
Photo:

Manufacturer:	Elkay	
		Description:		
		Drinking Fountain Bubbler		
		Result:	<1.0	ppb
		Date Sampled:	1/15/2024	By: NJ
Recommended Action:

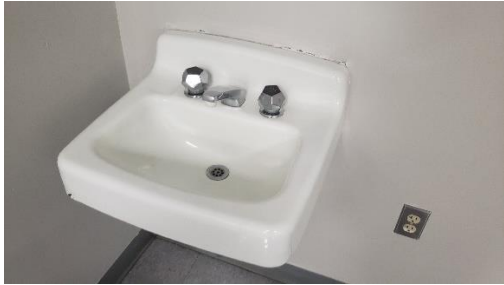
ID:	334-KSD-07	Location:	Title 1 Room 325	
Photo:

Manufacturer:	Unknown	
		Description:		
		Classroom Sink		
		Result:	5.5	ppb
		Date Sampled:	1/15/2024	By: NJ
Recommended Action:		Replace Fixture/Unit and Resample

In accordance with the requirements set forth in Missouri Bill 681/662, fixtures exhibiting lead concentrations above 5 ppb must be remediated by replacement of lead-containing pipes, solder, fittings or fixtures with lead-free components, or the school shall install filtration at each point where water enters the building until such time as the source can be remediated. If installing a filter is not feasible, the school shall provide purified water at each outlet inventoried.

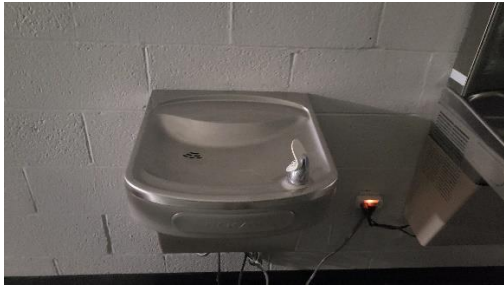
ID:	334-KSD-08	Location:	325 Hallway	
Photo:

Manufacturer:	Elkay	
		Description:		
		Drinking Fountain Bubbler, Left		
		Result:	<1.0	ppb
		Date Sampled:	1/15/2024	By: NJ
Recommended Action:

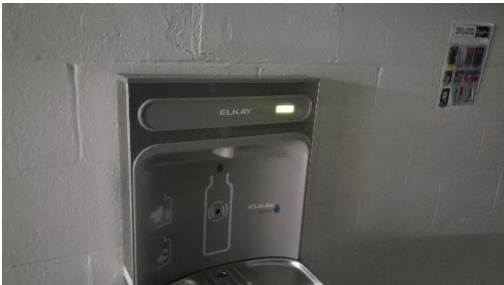
ID:	334-KSD-09	Location:	325 Hallway	
Photo:

Manufacturer:	Elkay	
		Description:		
		Drinking Fountain Bottle Filler		
		Result:	<1.0	ppb
		Date Sampled:	1/15/2024	By: NJ
Recommended Action:

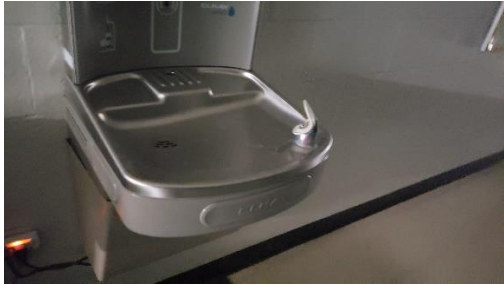
ID:	334-KSD-10	Location:	325 Hallway		
Photo:

Manufacturer:	Elkay		
		Description:			
		Drinking Fountain Bubbler, Right			
		Result:	<1.0	ppb	
		Date Sampled:	1/15/2024	By:	NJ
Recommended Action:

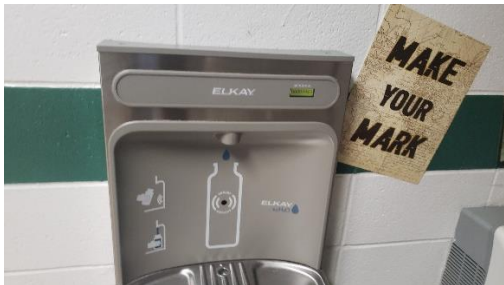
ID:	334-KSD-11	Location:	Central Office Hallway		
Photo:

Manufacturer:	Elkay		
		Description:			
		Drinking Fountain Bottle Filler			
		Result:	3.8	ppb	
		Date Sampled:	1/15/2024	By:	NJ
Recommended Action:

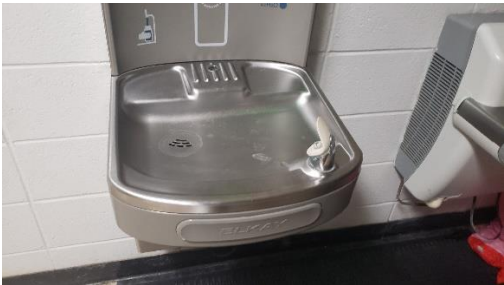
ID:	334-KSD-12	Location:	Central Office Hallway		
Photo:

Manufacturer:	Elkay		
		Description:			
		Drinking Fountain Bubbler, Left			
		Result:	1.7	ppb	
		Date Sampled:	1/15/2024	By:	NJ
Recommended Action:

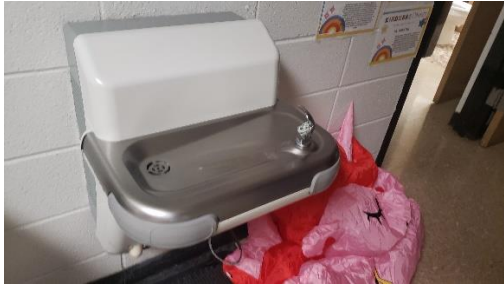
ID:	334-KSD-13	Location:	Central Office Hallway	
Photo:

Manufacturer:	Halsey-Taylor	
		Description:		
		Drinking Fountain Bubbler, Right		
		Result:	4.5	ppb
		Date Sampled:	1/15/2024	By: NJ
Recommended Action:

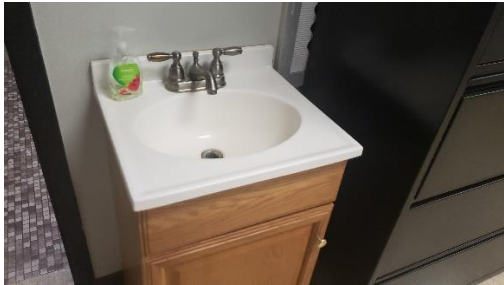
ID:	334-KSD-14	Location:	Classroom 300	
Photo:

Manufacturer:	Peerless	
		Description:		
		Classroom Sink		
		Result:	9.1	ppb
		Date Sampled:	1/15/2024	By: NJ
Recommended Action:		Replace Fixture/Unit and Resample

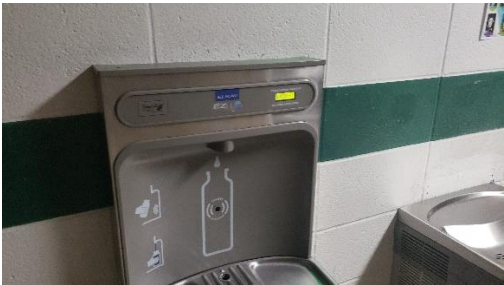
ID:	334-KSD-15	Location:	301 Hallway	
Photo:

Manufacturer:	Elkay	
		Description:		
		Drinking Fountain Bottle Filler		
		Result:	2.8	ppb
		Date Sampled:	1/15/2024	By: NJ
Recommended Action:

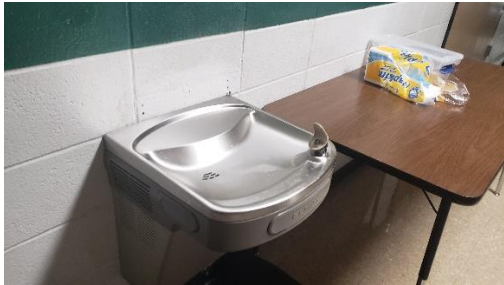
ID:	334-KSD-17	Location:	301 Hallway	
Photo:

Manufacturer:	Elkay	
		Description:		
		Drinking Fountain Bubbler, Right		
		Result:	1.8	ppb
		Date Sampled:	1/15/2024	By: NJ
Recommended Action:

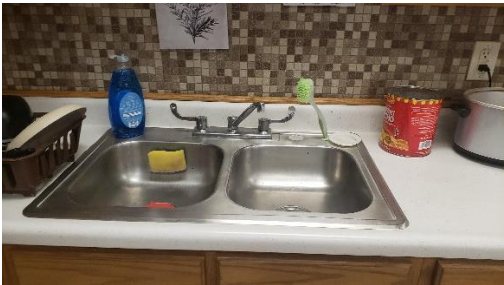
ID:	334-KSD-18	Location:	301 FACS	
Photo:

Manufacturer:	Unknown	
		Description:		
		East South Wall Station		
		Result:	9.7	ppb
		Date Sampled:	1/15/2024	By: NJ
Recommended Action:		Replace Fixture/Unit and Resample

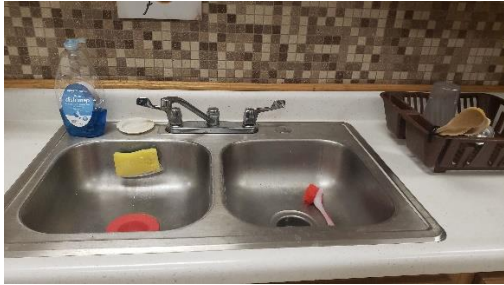
ID:	334-KSD-19	Location:	301 FACS	
Photo:

Manufacturer:	Delta	
		Description:		
		Center South Wall Station		
		Result:	6.4	ppb
		Date Sampled:	1/15/2024	By: NJ
Recommended Action:		Replace Fixture/Unit and Resample

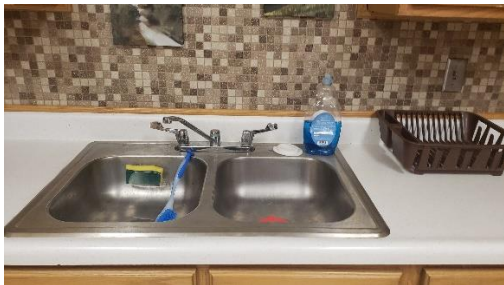
ID:	334-KSD-20	Location:	301 FACS	
Photo:

Manufacturer:	Delta	
		Description:		
		West Wall Station		
		Result:	14.7	ppb
		Date Sampled:	1/15/2024	By: NJ
Recommended Action:		Replace Fixture/Unit and Resample

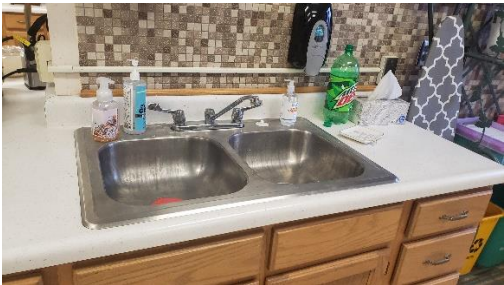
ID:	334-KSD-21	Location:	301 FACS	
Photo:

Manufacturer:	Delta	
		Description:		
		North Station		
		Result:	9.1	ppb
		Date Sampled:	1/15/2024	By: NJ
Recommended Action:		Replace Fixture/Unit and Resample

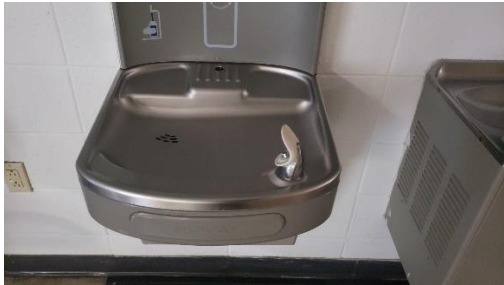
ID:	334-KSD-23	Location:	High School Office	
Photo:

Manufacturer:	Elkay	
		Description:		
		Drinking Fountain Bubbler, Left (Non-Functional)		
		Result:	<b>NA</b>	ppb
		Date Sampled:	1/15/2024	By: NJ
Recommended Action:		<b>Sample prior to returning to service</b>

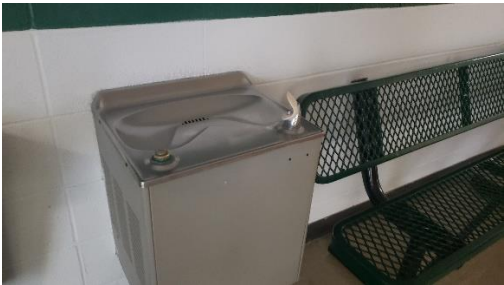
ID:	334-KSD-24	Location:	High School Office	
Photo:

Manufacturer:	Unknown	
		Description:		
		Drinking Fountain Bubbler, Right		
		Result:	<1.0	ppb
		Date Sampled:	1/15/2024	By: NJ
Recommended Action:

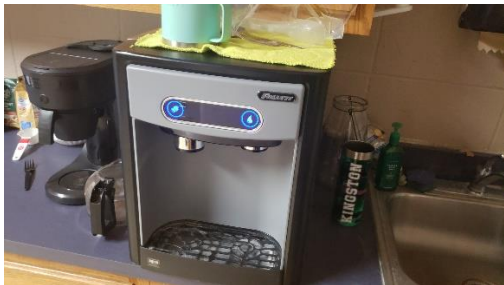
ID:	334-KSD-26	Location:	High School Office	
Photo:

Manufacturer:	Follett	
		Description:		
		Water Cooler		
		Result:	<1.0	ppb
		Date Sampled:	1/15/2024	By: NJ
Recommended Action:

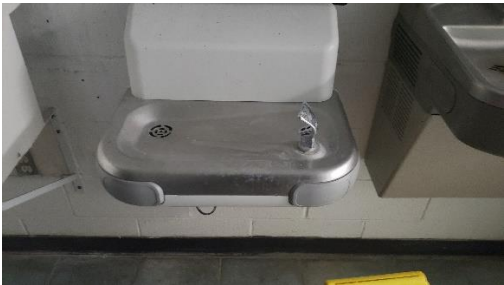
ID:	334-KSD-27	Location:	Arts Hallway	
Photo:

Manufacturer:	Halsey-Taylor	
		Description:		
		Drinking Fountain Bubbler, Left		
		Result:	<1.0	ppb
		Date Sampled:	1/15/2024	By: NJ
Recommended Action:

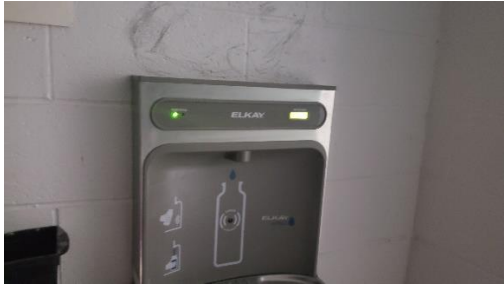
ID:	334-KSD-28	Location:	Arts Hallway	
Photo:

Manufacturer:	Elkay	
		Description:		
		Drinking Fountain Bottle Filler		
		Result:	<1.0	ppb
		Date Sampled:	1/15/2024	By: NJ
Recommended Action:

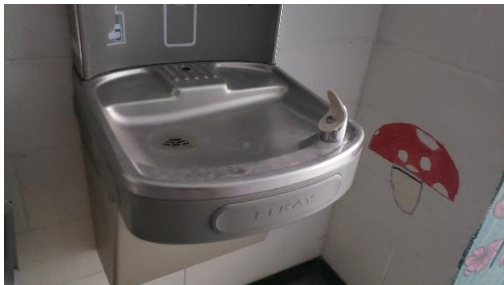
ID:	334-KSD-29	Location:	Arts Hallway	
Photo:

Manufacturer:	Elkay	
		Description:		
		Drinking Fountain Bubbler, Right (Non-Functional)		
		Result:	NA	ppb
		Date Sampled:	1/15/2024	By: NJ
Recommended Action:		Sample prior to returning to service

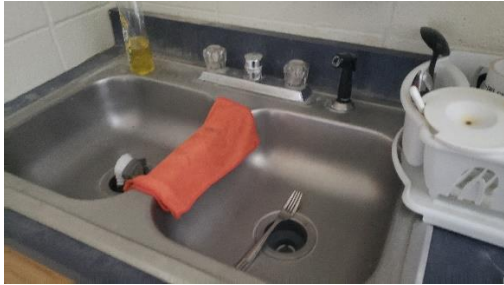
ID:	334-KSD-31	Location:	Teacher's Lounge 2F	
Photo:

Manufacturer:	Unknown	
		Description:		
		Kitchenette Sink		
		Result:	1.4	ppb
		Date Sampled:	1/15/2024	By: NJ
Recommended Action:

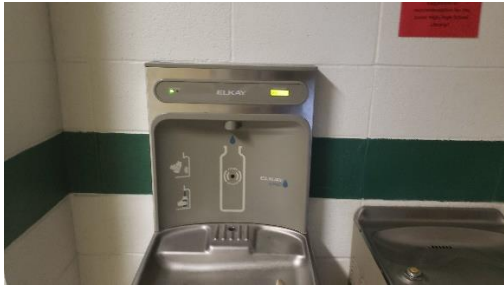
ID:	334-KSD-32	Location:	2nd Floor Hallway	
Photo:

Manufacturer:	Elkay	
		Description:		
		Drinking Fountain Bottle Filler		
		Result:	<1.0	ppb
		Date Sampled:	1/15/2024	By: NJ
Recommended Action:

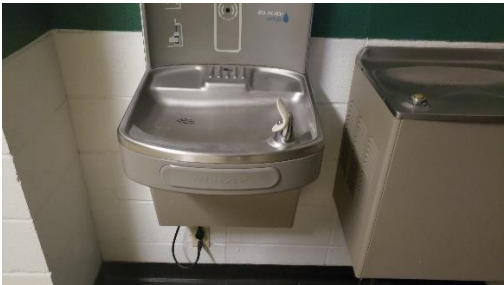
ID:	334-KSD-33	Location:	2nd Floor Hallway	
Photo:

Manufacturer:	Elkay	
		Description:		
		Drinking Fountain Bubbler, Left		
		Result:	<1.0	ppb
		Date Sampled:	1/15/2024	By: NJ
Recommended Action:

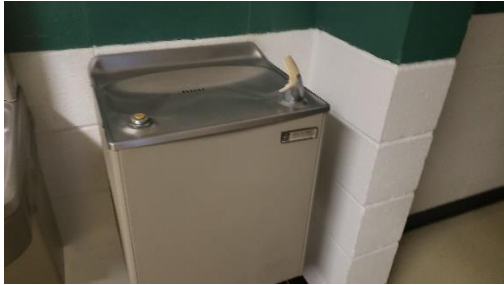
ID:	334-KSD-34	Location:	2nd Floor Hallway	
Photo:

Manufacturer:	Elkay	
		Description:		
		Drinking Fountain Bubbler, Right		
		Result:	<1.0	ppb
		Date Sampled:	1/15/2024	By: NJ
Recommended Action:

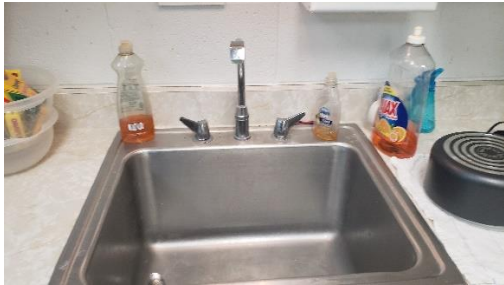
ID:	334-KSD-35	Location:	FACS 207	
Photo:

Manufacturer:	Unknown	
		Description:		
		East Wall Station		
		Result:	1.9	ppb
		Date Sampled:	1/15/2024	By: NJ
Recommended Action:

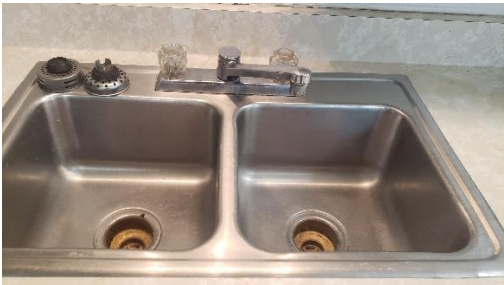
ID:	334-KSD-36	Location:	FACS 207	
Photo:

Manufacturer:	Unknown	
		Description:		
		South Wall Station East		
		Result:	1.1	ppb
		Date Sampled:	1/15/2024	By: NJ
Recommended Action:

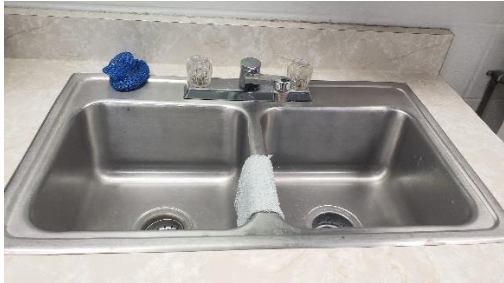
ID:	334-KSD-37	Location:	FACS 207	
Photo:

Manufacturer:	Moen	
		Description:		
		South Wall Station West		
		Result:	<1.0	ppb
Date Sampled:		1/15/2024	By:	NJ
Recommended Action:

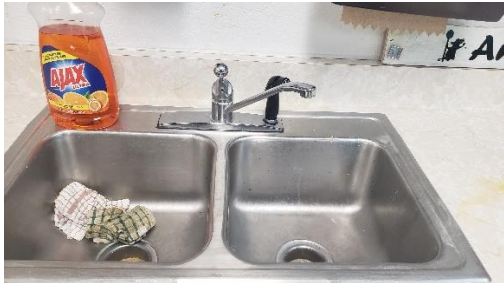
ID:	334-KSD-38	Location:	FACS 207	
Photo:

Manufacturer:	Delta	
		Description:		
		West Wall Station		
		Result:	1.8	ppb
Date Sampled:		1/15/2024	By:	NJ
Recommended Action:

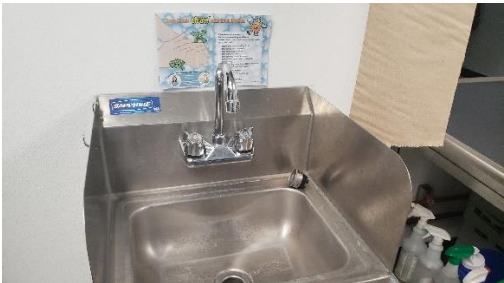
ID:	334-KSD-39	Location:	Kitchen Dish Room	
Photo:

Manufacturer:	Unknown	
		Description:		
		Hand Washing Sink		
		Result:	8	ppb
Date Sampled:		1/15/2024	By:	NJ
Recommended Action:		Replace Fixture/Unit and Resample

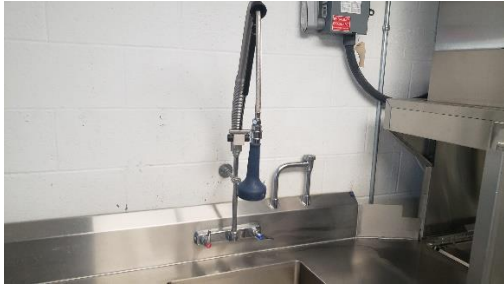
ID:	334-KSD-40	Location:	Kitchen Dish Room		
Photo:

Manufacturer:	T&S Brass		
		Description:			
		Kitchen Dish Sprayer			
		Result:	<1.0	ppb	
		Date Sampled:	1/15/2024	By:	NJ
Recommended Action:

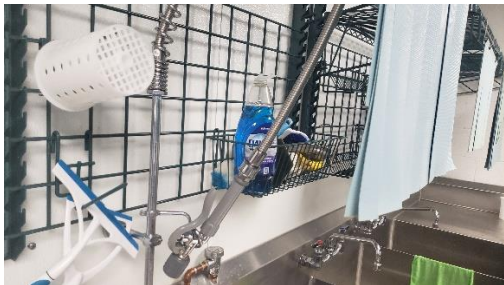
ID:	334-KSD-41	Location:	Kitchen Dish Room		
Photo:

Manufacturer:	T&S Brass		
		Description:			
		Kitchen Dish Sprayer with Faucet			
		Result:	1	ppb	
		Date Sampled:	1/15/2024	By:	NJ
Recommended Action:

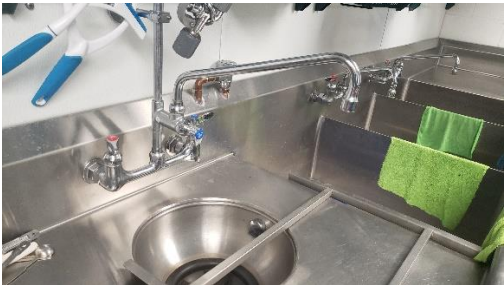
ID:	334-KSD-42	Location:	Kitchen Dish Room		
Photo:

Manufacturer:	T&S Brass		
		Description:			
		Faucet with Dish Sprayer & Disposal			
		Result:	<1.0	ppb	
		Date Sampled:	1/15/2024	By:	NJ
Recommended Action:

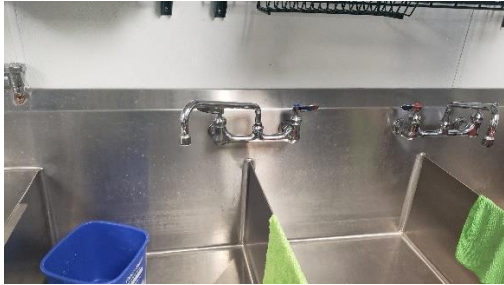
ID:	334-KSD-43	Location:	Kitchen Dish Room	
Photo:

Manufacturer:	T&S Brass	
		Description:		
		Dish Station, Left		
		Result:	<1.0	ppb
		Date Sampled:	1/15/2024	By: NJ
Recommended Action:

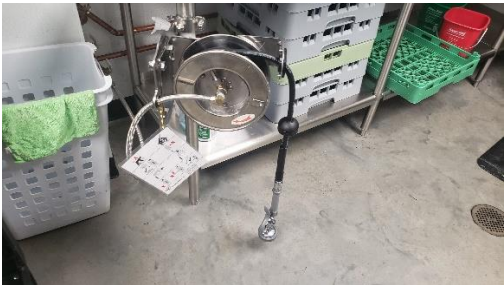
ID:	334-KSD-45	Location:	Kitchen Dish Room	
Photo:

Manufacturer:	T&S Brass	
		Description:		
		Kitchen Dish Sprayer Floor Hose		
		Result:	<1.0	ppb
		Date Sampled:	1/15/2024	By: NJ
Recommended Action:

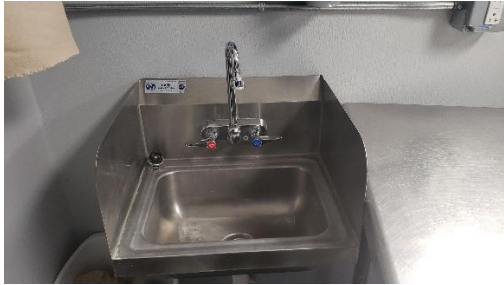
ID:	334-KSD-46	Location:	Kitchen	
Photo:

Manufacturer:	T&S Brass	
		Description:		
		Hand Washing Sink		
		Result:	<1.0	ppb
		Date Sampled:	1/15/2024	By: NJ
Recommended Action:

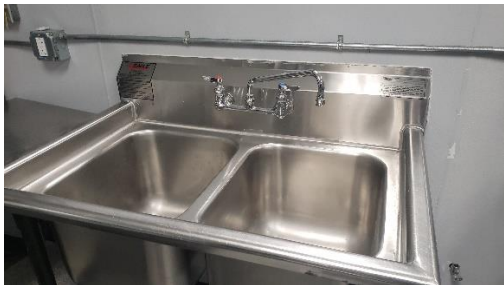
ID:	334-KSD-47	Location:	Kitchen	
Photo:

Manufacturer:	T&S Brass	
		Description:		
		Prep Sink		
		Result:	2.2	ppb
		Date Sampled:	1/15/2024	By: NJ
Recommended Action:

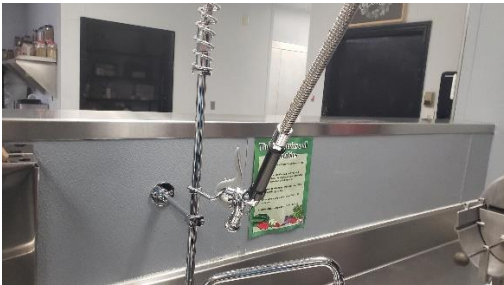
ID:	334-KSD-48	Location:	Kitchen	
Photo:

Manufacturer:	T&S Brass	
		Description:		
		Kitchen Dish Sprayer with Faucet		
		Result:	<1.0	ppb
		Date Sampled:	1/15/2024	By: NJ
Recommended Action:

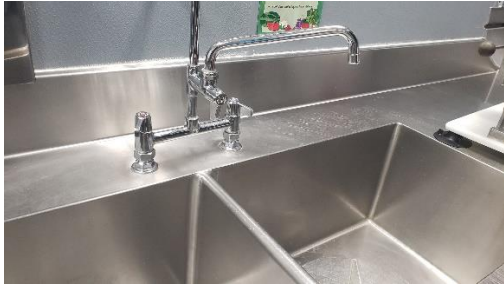
ID:	334-KSD-49	Location:	Kitchen	
Photo:

Manufacturer:	T&S Brass	
		Description:		
		Sink Faucet with Dish Sprayer		
		Result:	<1.0	ppb
		Date Sampled:	1/15/2024	By: NJ
Recommended Action:

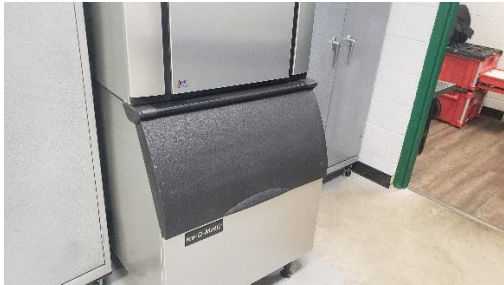
Manufacturer:	Ice-O-Matic	
		Description:		
		Ice Machine (Non-Functional)		
		Result:	N/A	ppb
		Date Sampled:	1/15/2024	By: NJ
Recommended Action:		Sample prior to returning to service

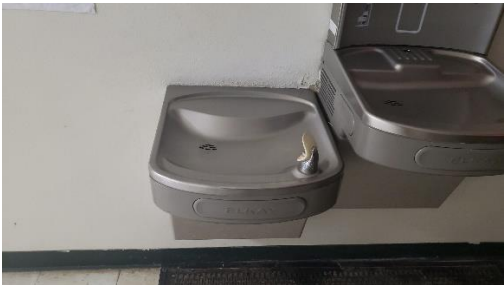
ID:	334-KSD-51	Location:	Elementary West Cross	
Photo:

Manufacturer:	Elkay	
		Description:		
		Drinking Fountain Bubbler, Left		
		Result:	<1.0	ppb
		Date Sampled:	1/15/2024	By: NJ
Recommended Action:

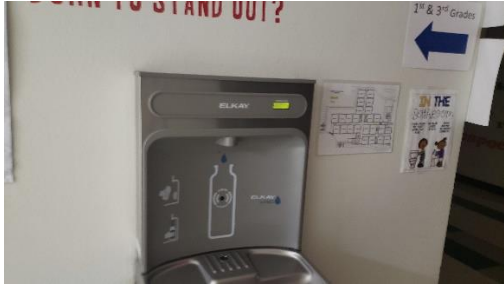
ID:	334-KSD-52	Location:	Elementary West Cross	
Photo:

Manufacturer:	Elkay	
		Description:		
		Drinking Fountain Bottle Filler		
		Result:	<1.0	ppb
Date Sampled:		1/15/2024	By:	NJ
Recommended Action:

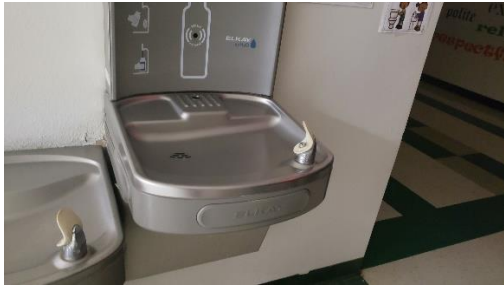
ID:	334-KSD-53	Location:	Elementary West Cross	
Photo:

Manufacturer:	Elkay	
		Description:		
		Drinking Fountain Bubbler, Right		
		Result:	<1.0	ppb
Date Sampled:		1/15/2024	By:	NJ
Recommended Action:

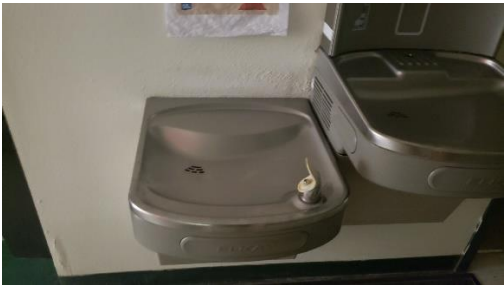
ID:	334-KSD-54	Location:	Elementary East Cross	
Photo:

Manufacturer:	Elkay	
		Description:		
		Drinking Fountain Bubbler, Left		
		Result:	<1.0	ppb
Date Sampled:		1/15/2024	By:	NJ
Recommended Action:

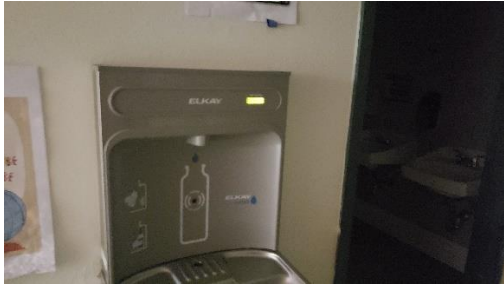
ID:	334-KSD-55	Location:	Elementary East Cross		
Photo:

Manufacturer:	Elkay		
		Description:			
		Drinking Fountain Bottle Filler			
		Result:	<1.0	ppb	
		Date Sampled:	1/15/2024	By:	NJ
Recommended Action:

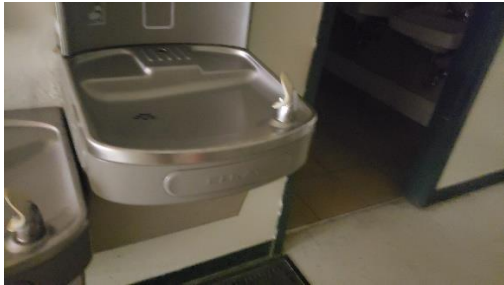
ID:	334-KSD-56	Location:	Elementary East Cross		
Photo:

Manufacturer:	Elkay		
		Description:			
		Drinking Fountain Bubbler, Right			
		Result:	<1.0	ppb	
		Date Sampled:	1/15/2024	By:	NJ
Recommended Action:

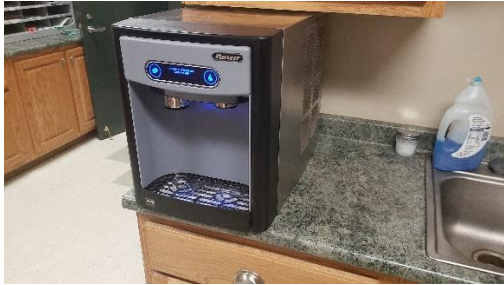
ID:	334-KSD-58	Location:	Elementary Office	
Photo:

Manufacturer:	Follett	
		Description:		
		Water Cooler		
		Result:	<1.0	ppb
		Date Sampled:	1/15/2024	By: NJ
Recommended Action:

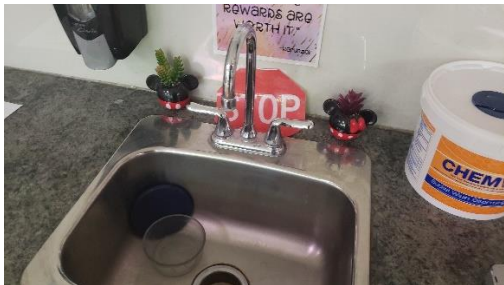
ID:	334-KSD-59	Location:	Classroom 408	
Photo:

Manufacturer:	American Standard	
		Description:		
		Classroom Sink		
		Result:	<1.0	ppb
		Date Sampled:	1/15/2024	By: NJ
Recommended Action:

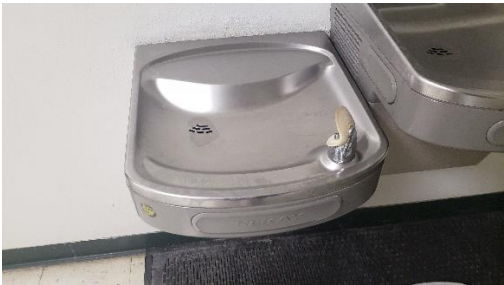
ID:	334-KSD-60	Location:	Elementary 400 Hall	
Photo:

Manufacturer:	Elkay	
		Description:		
		Drinking Fountain Bubbler, Left		
		Result:	<1.0	ppb
		Date Sampled:	1/15/2024	By: NJ
Recommended Action:

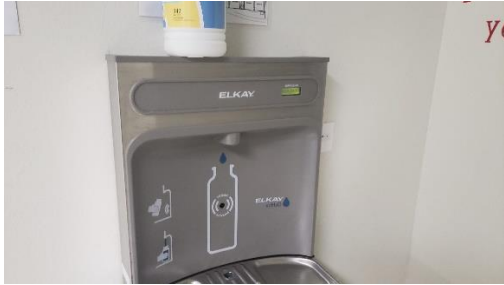
ID:	334-KSD-61	Location:	Elementary 400 Hall	
Photo:

Manufacturer:	Elkay	
		Description:		
		Drinking Fountain Bottle Filler		
		Result:	<1.0	ppb
		Date Sampled:	1/15/2024	By: NJ
Recommended Action:

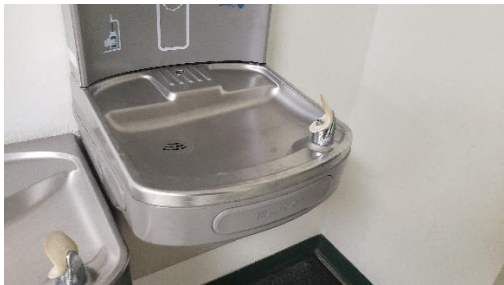
ID:	334-KSD-62	Location:	Elementary 400 Hall	
Photo:

Manufacturer:	Elkay	
		Description:		
		Drinking Fountain Bubbler, Right		
		Result:	<1.0	ppb
		Date Sampled:	1/15/2024	By: NJ
Recommended Action:

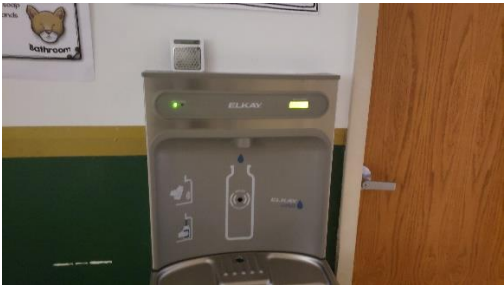
ID:	334-KSD-63	Location:	500 West Restrooms	
Photo:

Manufacturer:	Elkay	
		Description:		
		Drinking Fountain Bottle Filler		
		Result:	<1.0	ppb
		Date Sampled:	1/15/2024	By: NJ
Recommended Action:

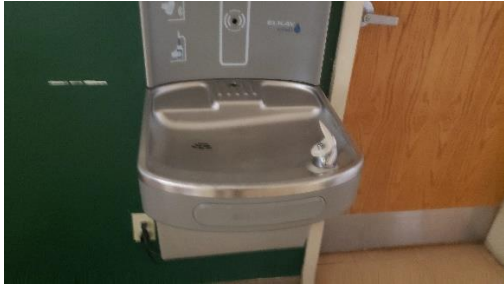
ID:	334-KSD-64	Location:	500 West Restrooms	
Photo:

Manufacturer:	Elkay	
		Description:		
		Drinking Fountain Bubbler		
		Result:	<1.0	ppb
		Date Sampled:	1/15/2024	By: NJ
Recommended Action:

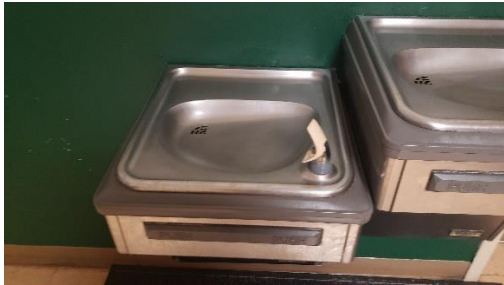
ID:	334-KSD-65	Location:	500 East Restrooms	
Photo:

Manufacturer:	Elkay	
		Description:		
		Drinking Fountain Bubbler, Left		
		Result:	<1.0	ppb
		Date Sampled:	1/15/2024	By: NJ
Recommended Action:

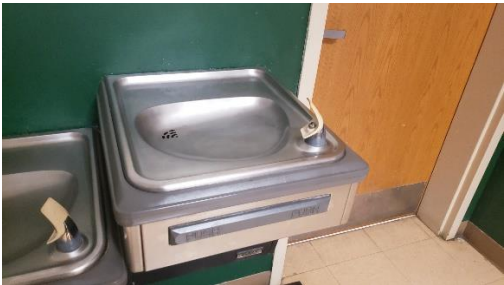
ID:	334-KSD-66	Location:	500 East Restrooms	
Photo:

Manufacturer:	Elkay	
		Description:		
		Drinking Fountain Bubbler, Right		
		Result:	<1.0	ppb
		Date Sampled:	1/15/2024	By: NJ
Recommended Action:

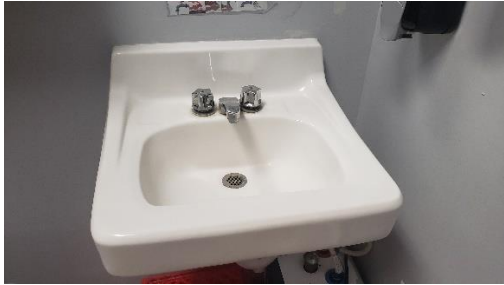
ID:	334-KSD-67	Location:	Nurse 808	
Photo:

Manufacturer:	Central	
		Description:		
		Nurse Sink		
		Result:	<1.0	ppb
		Date Sampled:	1/15/2024	By: NJ
Recommended Action:

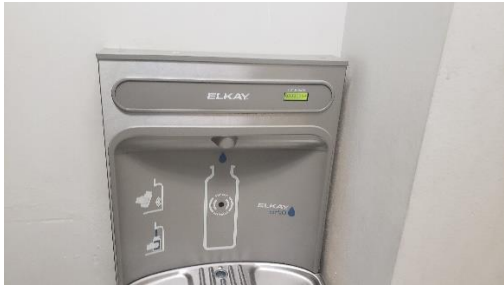
ID:	334-KSD-68	Location:	Gym Restrooms	
Photo:

Manufacturer:	Elkay	
		Description:		
		Drinking Fountain Bottle Filler		
		Result:	<1.0	ppb
		Date Sampled:	1/15/2024	By: NJ
Recommended Action:

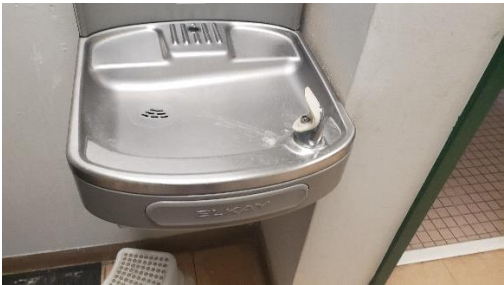
ID:	334-KSD-69	Location:	Gym Restrooms	
Photo:

Manufacturer:	Elkay	
		Description:		
		Drinking Fountain Bubbler		
		Result:	<1.0	ppb
		Date Sampled:	1/15/2024	By: NJ
Recommended Action:

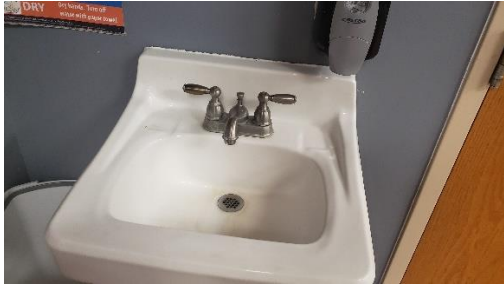
ID:	334-KSD-70	Location:	Kitchen		
Photo:

Manufacturer:	Peerless		
		Description:			
		Hand Washing Sink			
		Result:	<1.0	ppb	
		Date Sampled:	1/15/2024	By:	NJ
Recommended Action:

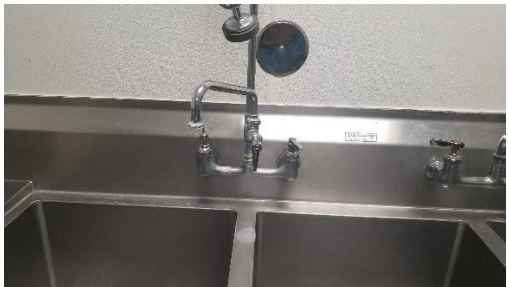
ID:	334-KSD-73	Location:	Kitchen		
Photo:

Manufacturer:	T&S Brass		
		Description:			
		Dish Station, Left			
		Result:	<1.0	ppb	
		Date Sampled:	1/15/2024	By:	NJ
Recommended Action:

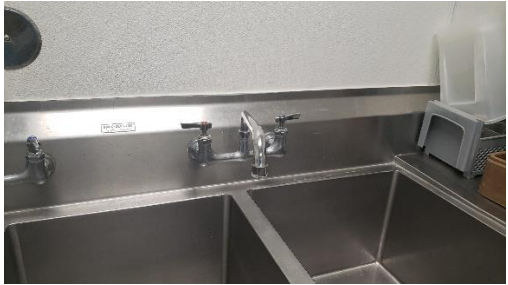
ID:	334-KSD-74	Location:	Kitchen		
Photo:

Manufacturer:	T&S Brass		
		Description:			
		Dish Station, Right			
		Result:	<1.0	ppb	
		Date Sampled:	1/15/2024	By:	NJ
Recommended Action:

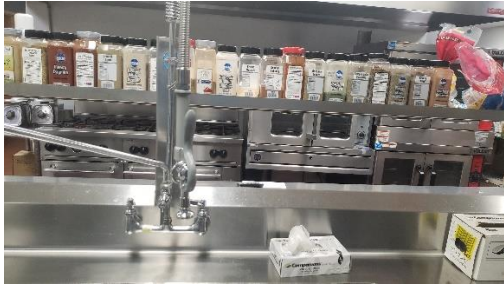
ID:	334-KSD-76	Location:	Kitchen		
Photo:

Manufacturer:	T&S Brass		
		Description:			
		Kitchen Dish Sprayer with Prep Sink			
		Result:	<1.0	ppb	
		Date Sampled:	1/15/2024	By:	NJ
Recommended Action:

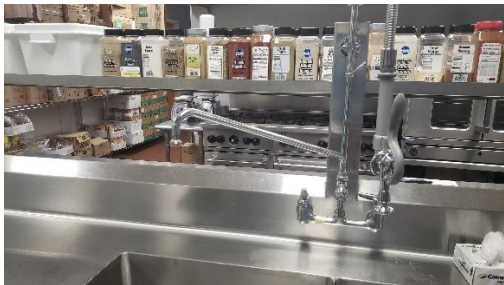
ID:	334-KSD-77	Location:	Kitchen		
Photo:

Manufacturer:	T&S Brass		
		Description:			
		Prep Sink			
		Result:	<1.0	ppb	
		Date Sampled:	1/15/2024	By:	NJ
Recommended Action:

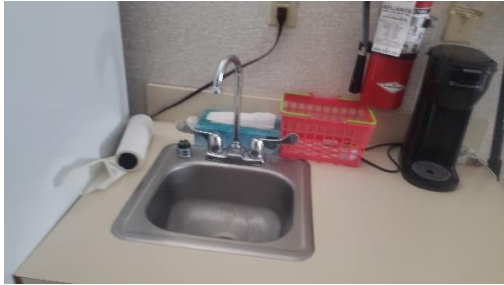
ID:	334-KSD-79	Location:	Daycare		
Photo:

Manufacturer:	Delta		
		Description:			
		Kitchen Hand Washing Sink			
		Result:	1.9	ppb	
		Date Sampled:	1/15/2024	By:	NJ
Recommended Action:

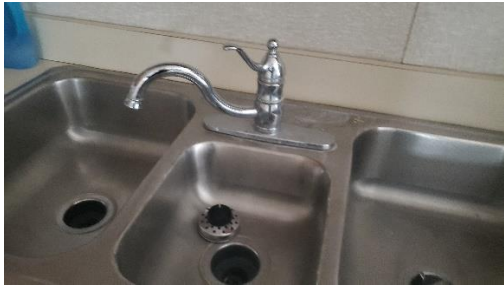
ID:	334-KSD-80	Location:	Daycare		
Photo:

Manufacturer:	Unknown		
		Description:			
		Kitchen Sink			
		Result:	<1.0	ppb	
		Date Sampled:	1/15/2024	By:	NJ
Recommended Action:
